# Manhole Inspection Summary

Manhole # S35Q\_\_035MH

Insp Date: **3/12/08 1:56 PM**

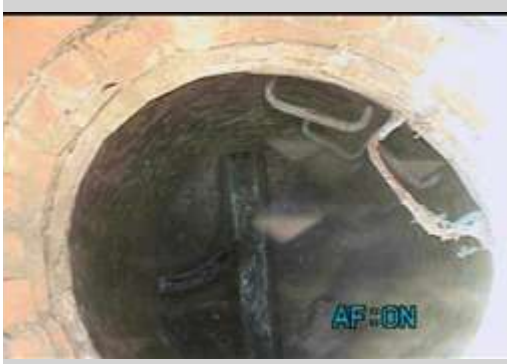
Defect 1

Count: **7** Missing: **1** ☒ **Corroded**

steps

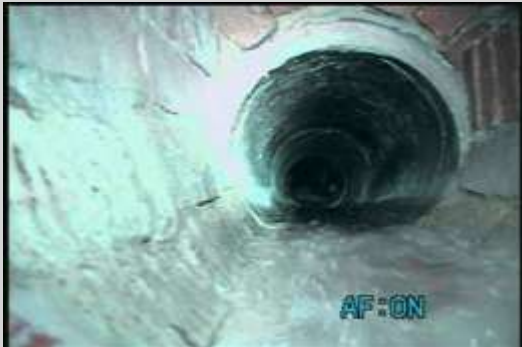
12 O'Clock Outflow

8 in. Circular Gravity Sewer  
Pipe Out @ 12 O'Clock

Pipe Material: **Clay** ☐ Pipe Lined

Invert Depth: **10.70** (ft.) Flow Characteristics: **Fast**

Infiltration: **None** Pipe Seal Cond: **Unknown**

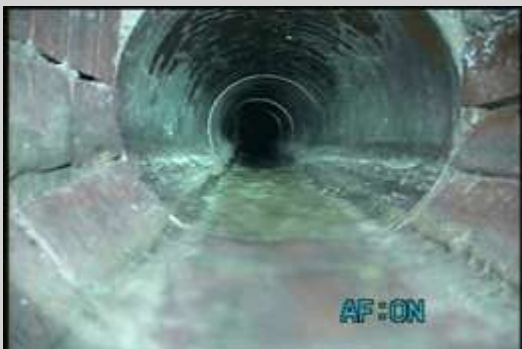
6 O'Clock Inflow

8 in. Circular Gravity Sewer  
Pipe In @ 6 O'Clock

Pipe Material: **Clay** ☐ Pipe Lined

Invert Depth: **10.60** (ft.) Flow Characteristics: **Fast**

Infiltration: **None** Pipe Seal Cond: **Unknown**

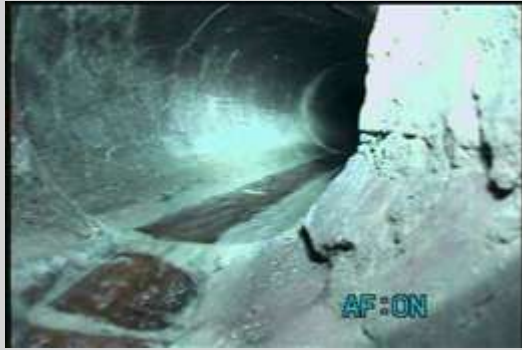
9 O'Clock Inflow

8 in. Circular Gravity Sewer

Pipe In @ 9 O'Clock

Pipe Material: **Clay** ☐ Pipe Lined

Invert Depth: **10.00** (ft.) Flow Characteristics: **Fast**

Infiltration: **None** Pipe Seal Cond: **Unknown**
